Radiation Source Loss case study

Doug Pringle
Manager,
Health and
Safety

Lost source - history

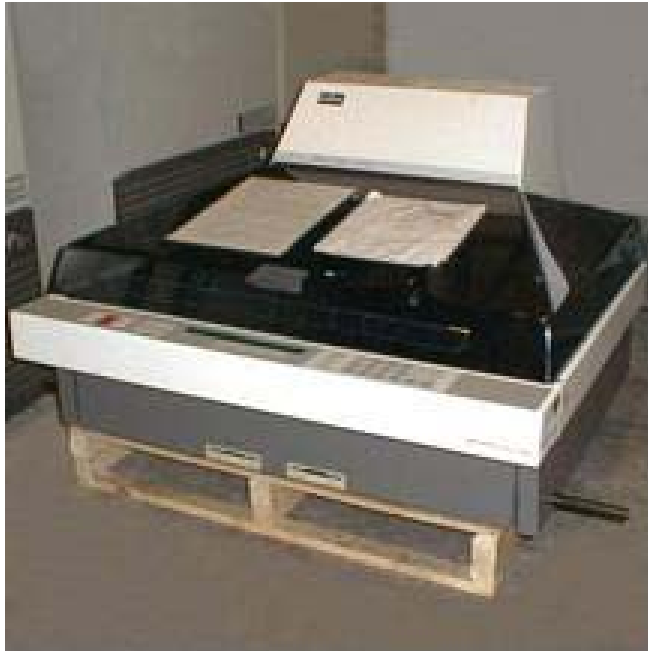
Wallac Liquid Scintillation counter

- 1985 purchased by Mu
- 1994 relocated to CRI (CRI licensee)
- located with similar counter owned by CRI
- ~ 2002 breaks down and not repaired by Mu
- 2004 CRI want bench space

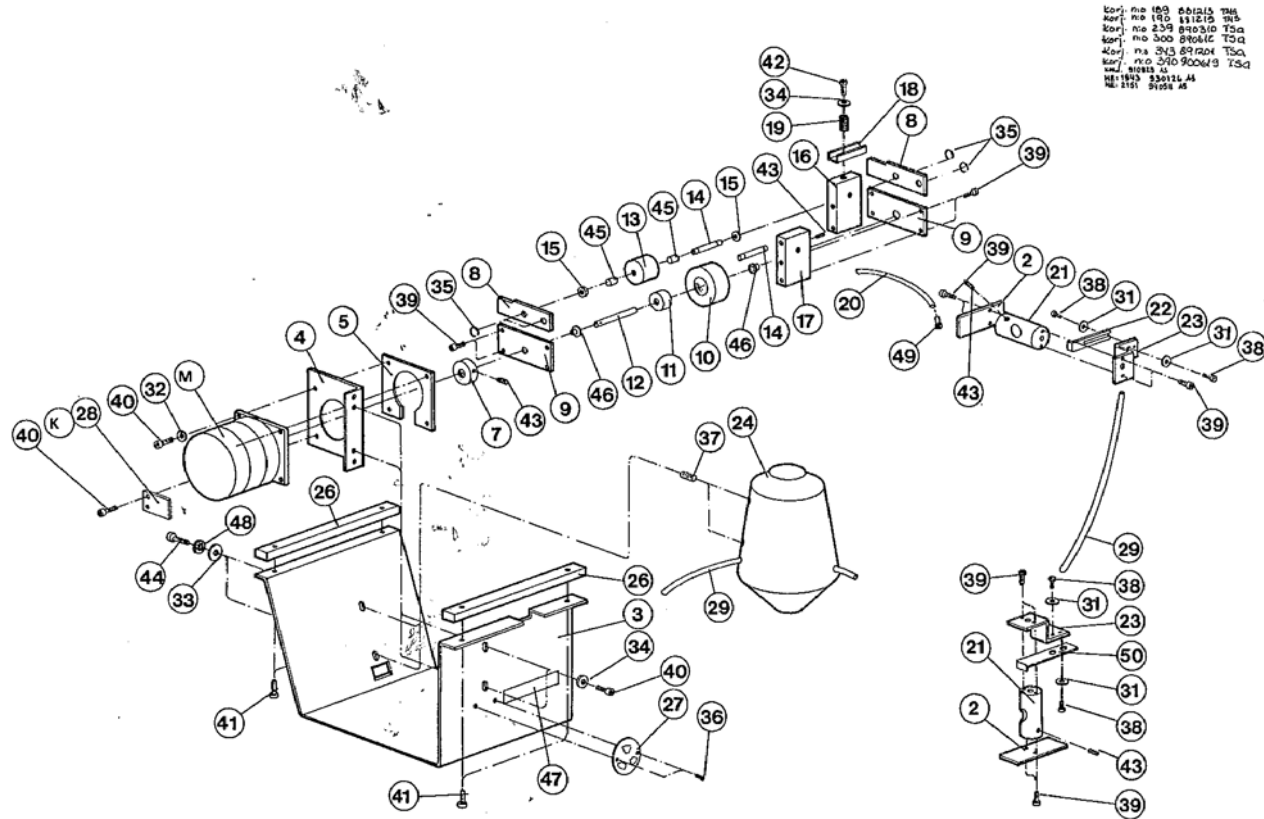
Wallac 140 series

Reference radiation source within counter

Eu-152 - gamma and beta emitter

Physical size – “BB” pellet
